HISTORIC RAILROADS ST. FRANCOIS COUNTY MINED AREAS

St. Francois County, Missouri

January 29, 2007

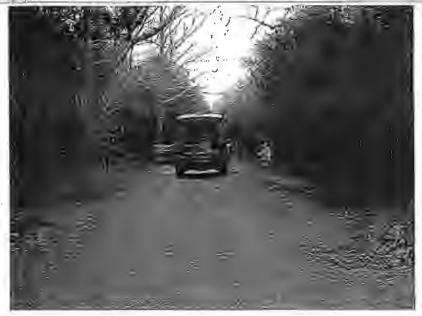
HRR-1, Looking east.

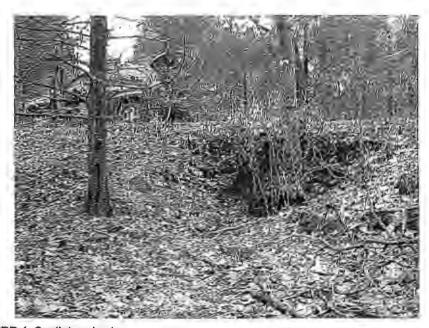
HRR-1, South to culvert.

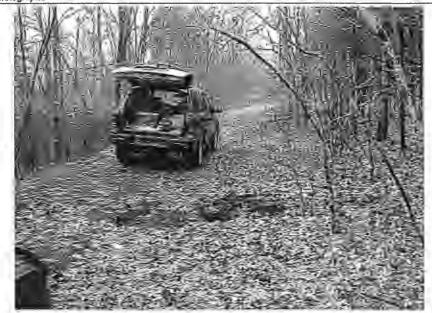
HRR-4, Looking south.

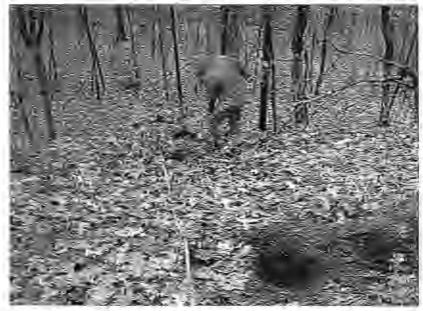
HRR-4, Downslope.

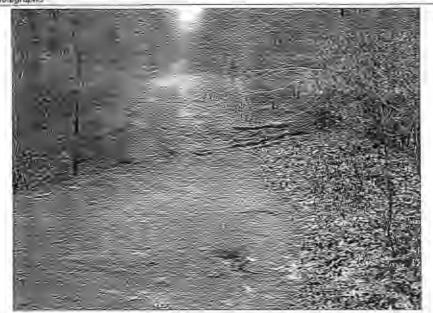
HRR-5, Northeast along railroad.

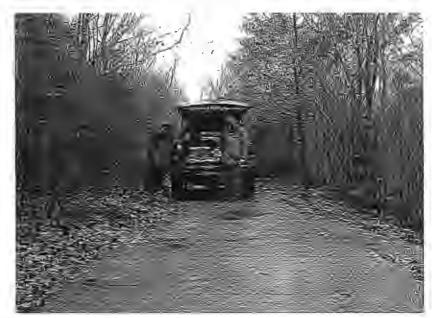
HRR-5, Looking southwest, transect in foreground.

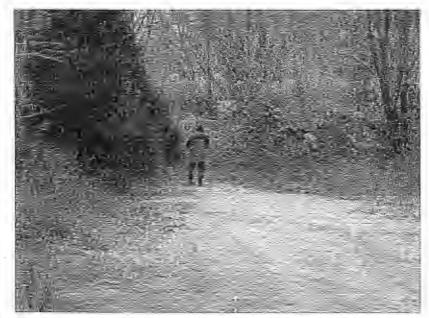
HRR-6, From ball field looking southeast down railroad to transect location.

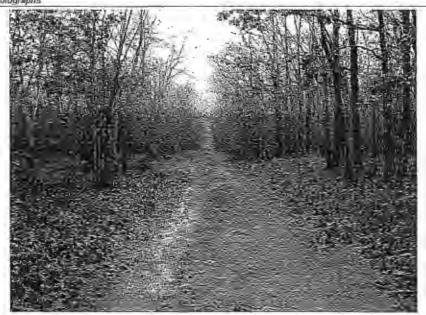
HRR-8, Looking north.

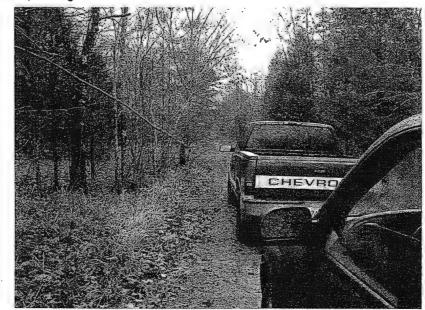
HRR-8, Looking south.

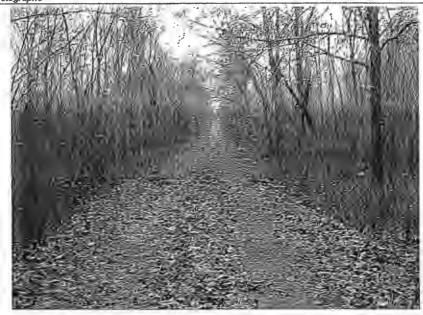
HRR-9, Looking west.

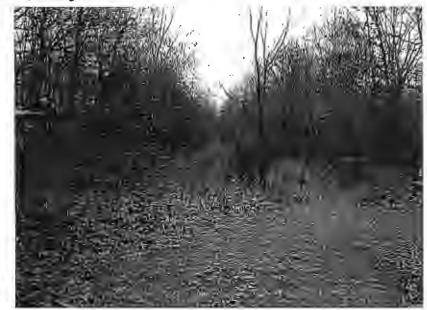
HRR-9, Looking east.

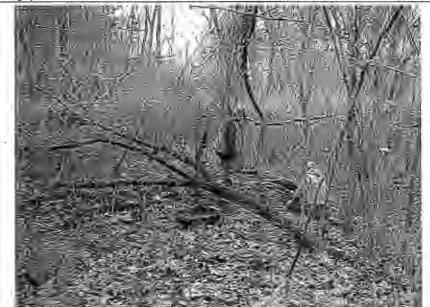
HRR-10, Looking north down rail.

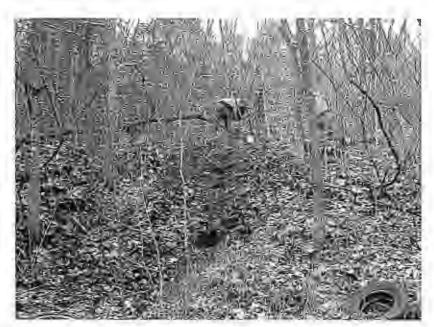
HRR-10, Looking west.

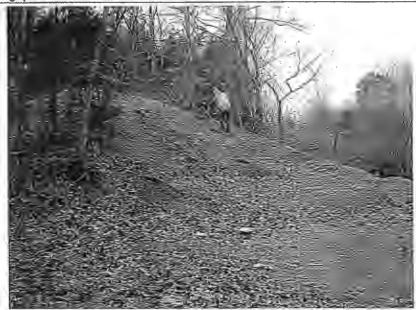
HRR-11, Eroded end, sample location.

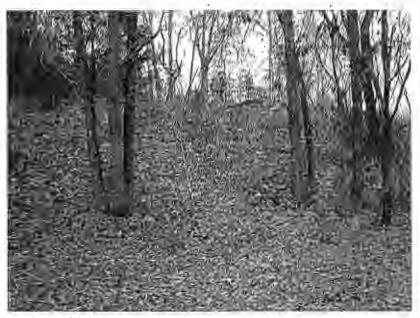
HRR-11, Transect for volume.

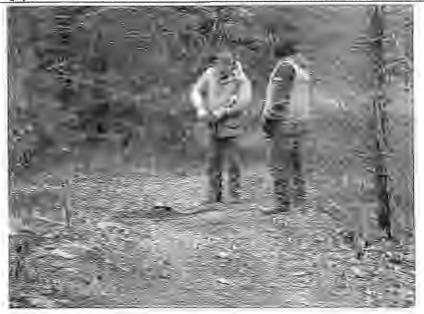
HRR-12, Looking downhill east southeast along railroad.

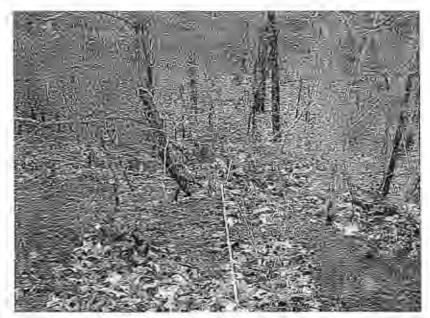
HRR-12, South down long slope on transect

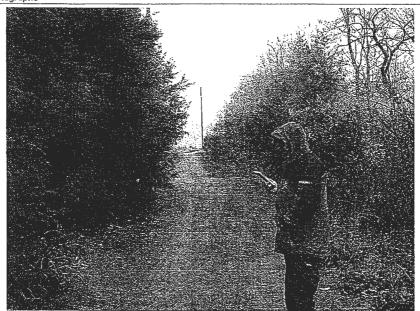
HRR-14, Looking south to Bonne Terre pile along railroad.
